**VENDOR SERVICE BULLETIN**  
**ATA 26-24**  
**FIRE PROTECTION – FIRE EXTINGUISHER -**  
**HIGH TEMPERATURE EXPOSURE - INSPECTION**

<b>PART MANUFACTURER</b>	umlaut engineering GmbH
<b>AFFECTED PART</b>	Hand-held Fire Extinguisher HAFEX, model type: P3APP003010A P3APP003010B P3APP003010C

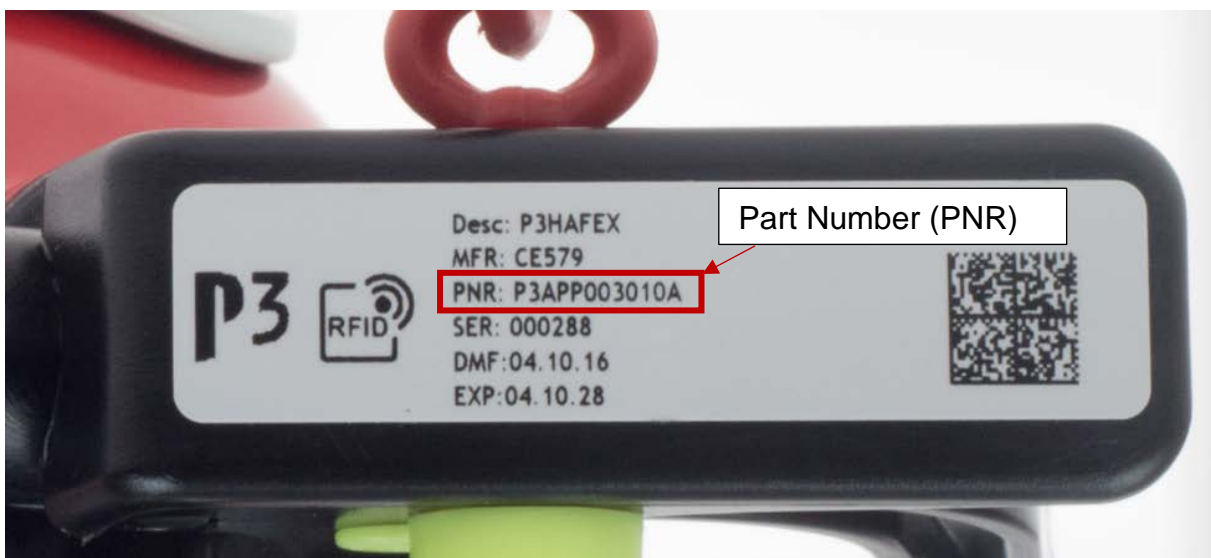
Figure 1: RFID Label.

On the RFID label located on the lever of the fire extinguisher, check the part number (PNR). Only PNR P3APP003010A, P3APP003010B, P3APP003010C are subject to this service bulletin. (refer to Figure 1).

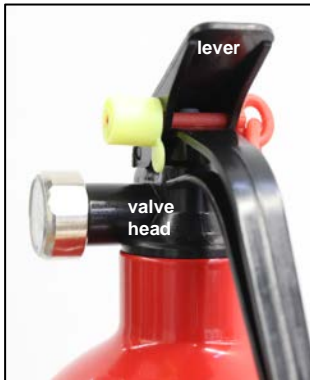
Figure 2: upright position

1. Remove the fire extinguisher from its bracket. **Refer to CMM 26-24-02 page 12001.**
2. Put extinguisher in upright position onto a flat and even surface with safety pin in place (Figure 2).
3. Push the lever up carefully with low force and using only one finger (Figure 3).
4. Release the lever.

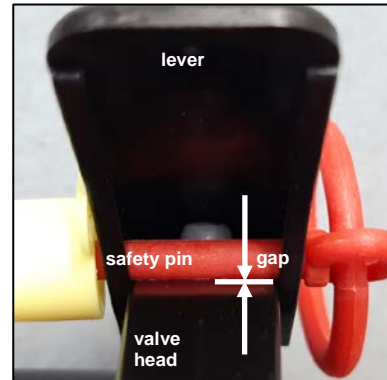
Figure 4: gap

5. Check presence of potential gap between safety pin and valve head (without touching the lever): check visually if the safety pin touches the valve head (Figure 4).

- a. Case 1: safety pin touches valve head: the extinguisher can be considered as not affected. No further action needed.
  - b. Case 2: safety pin does not touch valve head: If there is a gap or in case of doubt, proceed with step 6.

- a. Case 3: If the lever stays in its position without moving up on its own (without a gap between safety pin and valve head, refer to Figure 4): the extinguisher can be considered as not affected. No further action needed.

- b. Case 4: If the lever moves back up into its previous position on its own (showing the potential gap again), the extinguisher might be affected in its function and should be considered INOP and should be replaced according to instructions provided by the design holder.
